# Lowell Downtown Plan Update Technical Memorandum 2:

Physical Analysis of Downtown Study Area

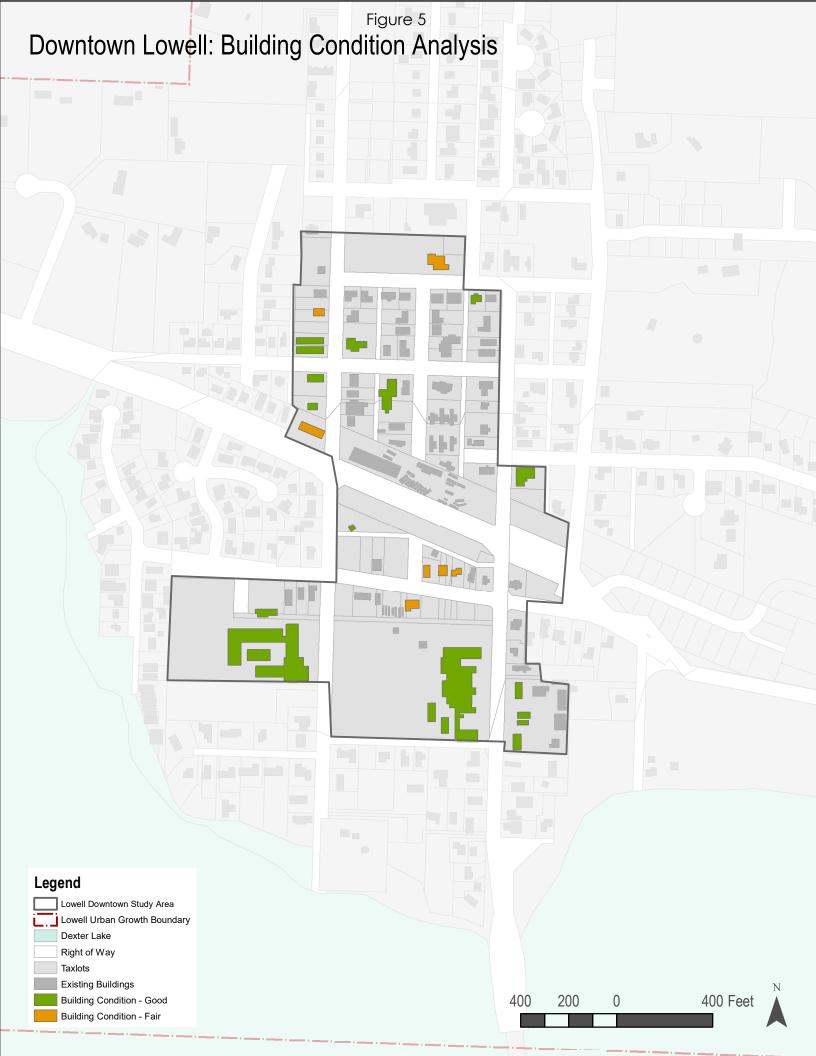
Figure 5- Building Condition Analysis

All buildings, except residences, were rated for their physical condition. Buildings are judged to be of good condition if there is no sign of physical damage or aging on the façade. Buildings are judged to be of fair condition if there is a sign of slight ageing of the façade. No buildings within the study area are judged to be of poor condition. In general, nonresidential buildings in the downtown area are in good condition; however, more could be done to beautify the neighborhood.

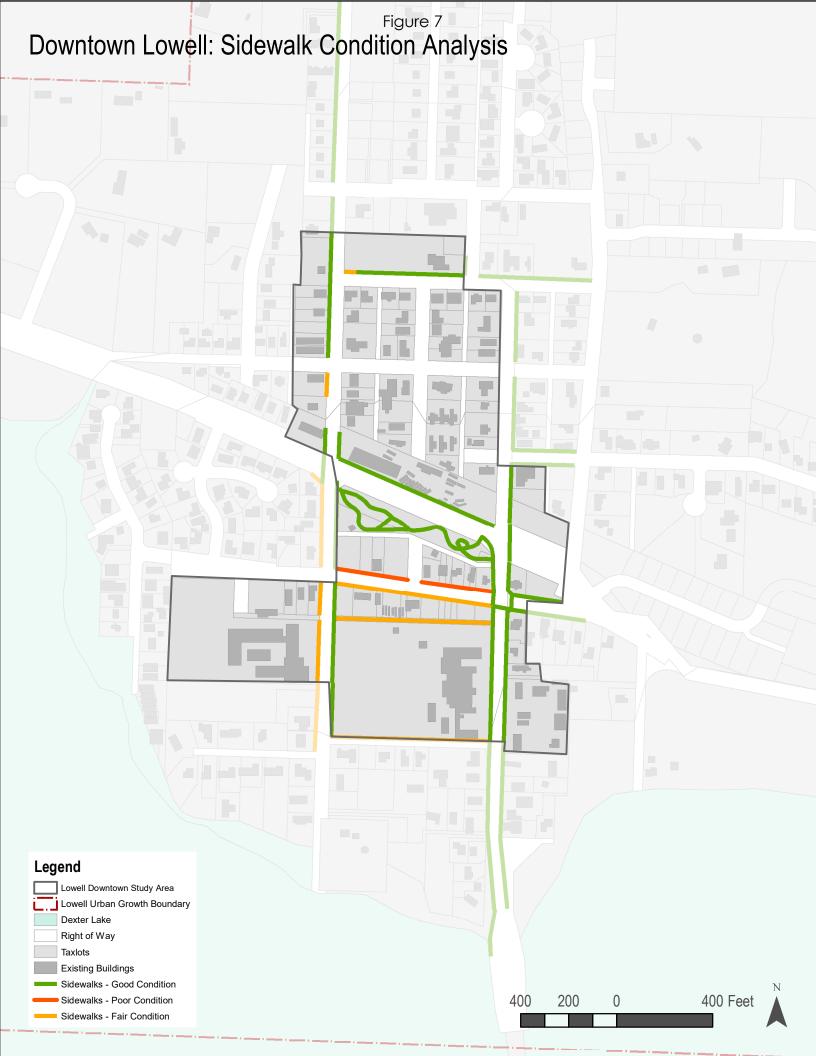
Figure 7- Sidewalk Condition Analysis

The sidewalks were evaluated based on their quality. Sidewalks of good quality, indicated in green, feature accessible ramps and tactile paving for the visually impaired. The good quality sidewalks also have even paving. The sidewalk running through Rolling Rock Park, shown below, is an example of a good quality

sidewalk in the downtown area. Fair quality sidewalks have rougher paving with no curb ramps on some intersections. Poor quality sidewalks have cracks, holes, and/or are slanted.

pedestrian road crossings which greatly improves pedestrian circulation. Over time, all of the sidewalks in the downtown area should be improved to good quality, connected sidewalks with accessible ramps.

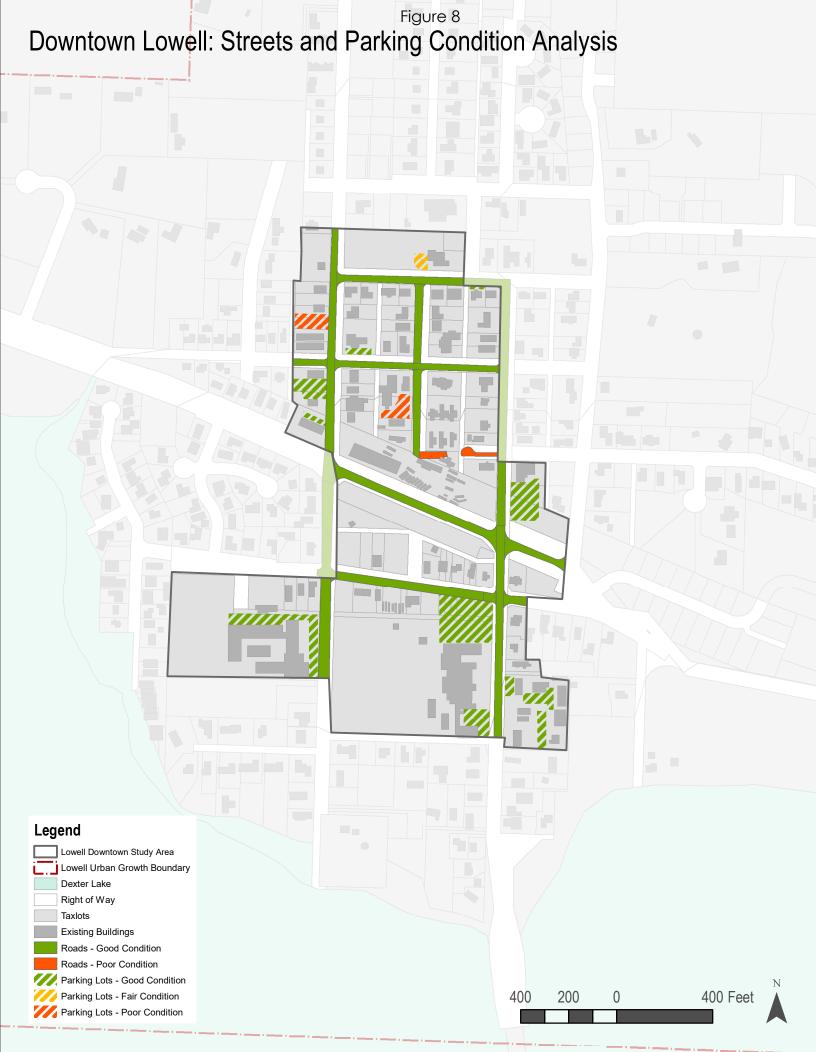
Figure 8 (including streetscapes) - Streets and Parking Condition Analysis

The team analyzed street and parking lot condition in the downtown study area. Good quality streets and parking lots have even paving, crosswalks, and clear markings. The intersection of North Shore Drive and Moss Street is an example of a good quality street and crosswalk. There were no streets deemed fair quality. Gravel roads were designated poor quality; however, this does not necessarily mean they need to be changed. Figures 8-A through 8-G are street sections of specific streets in the study area, indicated on the Streets and Parking Condition map. These help to indicate the current streetscape in the downtown area and will help with future planning efforts. Please note the street width measurements still need site verification.

The majority of parking lots in the study area are in good condition, such as the parking lot in front of Bridge Town Market, shown below. While the parking lot next to City Hall is paved, it was determined to be of fair condition because it lacks parking lines to differentiate between parking spots. The parking lots in poor condition are gravel parking lots.
