# Lowell Downtown Plan Update Technical Memorandum 2:

Physical Analysis of Downtown Study Area

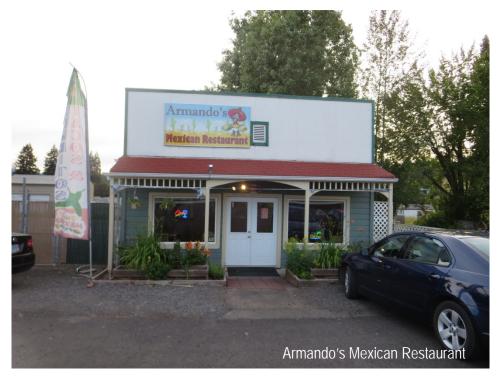
Access to food and beverage options are limited in the area. Year-round food establishments are few and spread out. Armando's Mexican Restaurant, shown below, stands out as a restaurant by itself on South Moss Street. The farmer's market offers an additional source of food items in downtown, but is only available once a week during summer months.

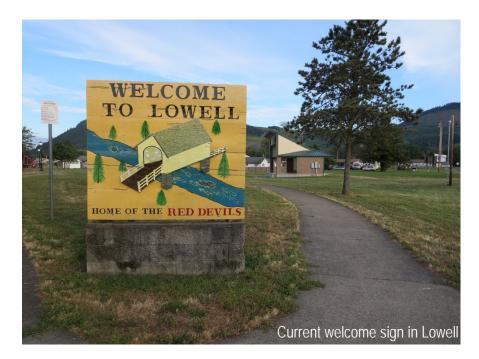
Distinct gateways help define an area and are an important way for a town to establish a sense of place. Currently, the only significant marker for downtown Lowell is the "Welcome to Lowell" sign placed at the northwest corner of Rolling Rock Park, shown below. While the sign is a distinct marker when approached from the north, one of the main entrances to Lowell is from the south, as cars come across the bridge on Dexter Lake. Another marker or gateway along S Pioneer Street would help to define the southern entrance to Lowell and the downtown area.
